Measuring / object data

WoodInspector

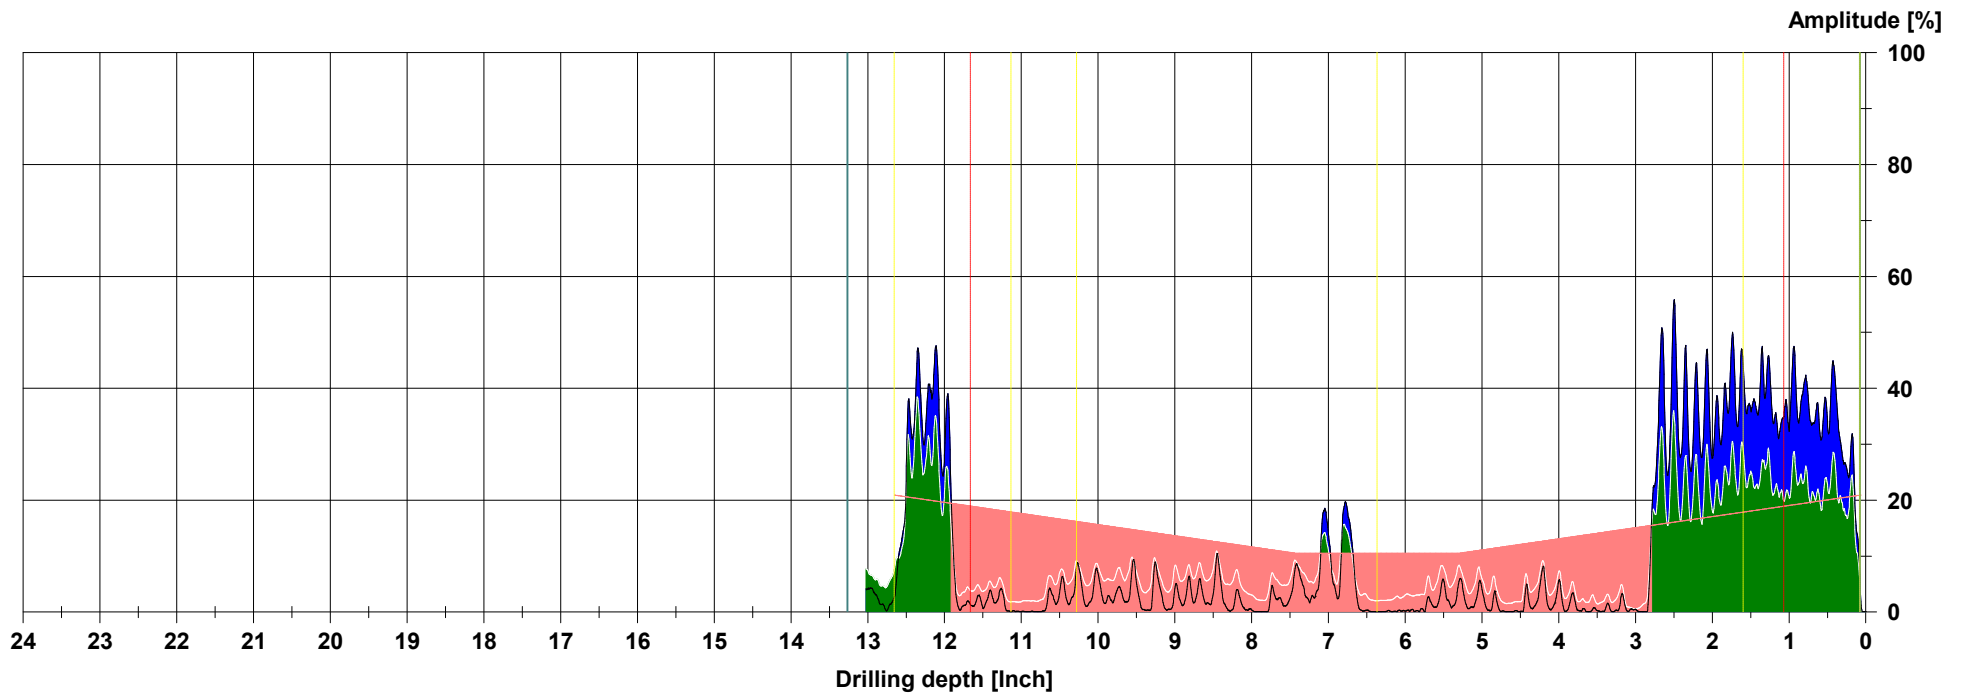
Measurement no.:	17	Speed	: 3000 r/min	Diameter:	11.50 in
ID number	: 50234	Needle state:	---	Level	:
Drilling depth	: 13.02 in	Tilt	: -29°	Direction:	:
Date	: 03/31/2021	Offset	: 70 / 272	Species	:
Time	: 09:55:00	Avg. curve	: off / off	Location	:
Feed	: 40 in/min	Name	:

Program	: Pole - FIRST_E 1.10	Sum decay	: 28.4% 44.1% 72.5%
Pole type	: 3BGL	Heart rot	: 28.4% 44.1% 72.5%
Measurement	: Below soil level	Shell rot	: No No
Defect pattern	: Heart rot	Remaining wall	: 21.6% 5.9% 13.8%
Result (auto)	: PRIORITY 1 REJ	Strength	: 89.6% 39.5% 64.5%
